**Orlando, Florida**  
**April 24-27, 2005**

## **CITY OF LOS ANGELES CONDUCTS A TEST INSTALLATION OF A NON-CIRCULAR WOUND PIPELINE REHABILITATION METHOD**

**Abstract:** The City of Los Angeles has been working to develop biddable alternatives to rehabilitate its 60+ miles of large diameter semi-elliptical sewers. Prior to the project described in this paper, only one trial installation of a non-circular lining product had been installed. This paper describes the installation of a corrosion barrier into a rectangular channel using a winding technique developed by Sekisui. This represents the first installation of this product in the United States.

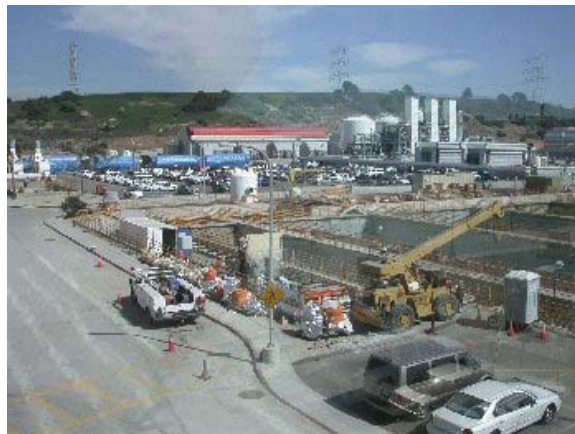
Figure 1. Hyperion Treatment Plant Emergency Bypass Channel

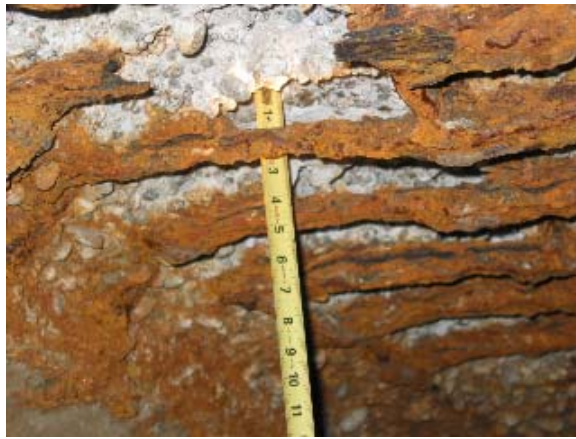
The City of Los Angeles' Hyperion Treatment Plant treats an average of 350 million gallons of sewage per day. Flow through the plant is expedited by an Intermediate Pump Station using open flight screw pumps. Discharge from the plant is assisted by discharge pumps into the five mile outfall. While the plant has full electrical backup, an emergency bypass channel (EBC) is also in place to divert flow into empty tanks in the event of power outage, equipment failure, or emergency plant shut down. This channel is 13-feet wide, 5-feet 4-inches high and has an overall length of 260 feet. The EBC has a straight section 190 feet long and a curved section 70 feet long (Figure 1). It was discovered to have severe corrosion at the soffit. (Figure 2.)

Figure 2. *Soffit Corrosion*

The structural repair of the channel could have been accomplished in several ways. However, at the time that the EBC repair became an approved project the Wastewater Conveyance Engineering Division of the City of Los Angeles Bureau of Engineering was actively looking for a satisfactory test installation site for the Sekisui SPR product. Initially several candidate sites for a test installation were considered including both live sewer locations in the North Outfall Sewer, and an abandoned section of semi-elliptical sewer. It was determined that the EBC rehabilitation project would provide an ideal opportunity for a trial demonstration. Because of the location and level of use of the EBC, it could be done in a location that would allow close inspection of the method of installation and ready access to the finished product to review the results.

The Emergency Bypass Channel project was intended to demonstrate the installation of the Sekisui SPR product. For this project the repair was considered as a corrosion barrier only, with the structural portion of the repair to be done by conventional means. Soffit repair was carried out by high pressure water blasting corroded areas to expose sound concrete, damaged rebar was spliced and doweled into sound concrete, and the area of repair was formed and new concrete was placed. Debris from water blasting was left in the channel, and ends of the channel were sandbagged and allowed to fill partially with water to simulate a wet sewer environment for the installation of the corrosion liner.

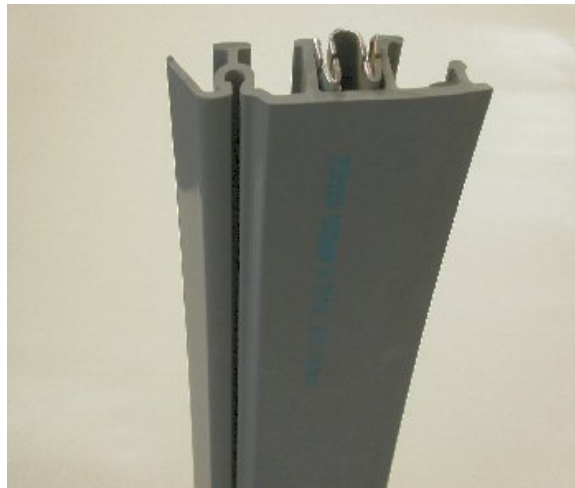
Figure 3. Sekisui SPR Profile

The Sekisui method winds a continuous strip of interlocking plastic (Figure 3) into a shape that closely approximates the deteriorated host channel. Winding is accomplished using a relatively small winding machine that travels down the channel at the head end of the completed liner. (Figure 4) One feature of particular interest to the City is the ability of the machine to be installed into the channel, and lining material can be fed to the machine through a maintenance hole, without the need to open the street. For winding a non-circular shape the plastic profile strip is reinforced by a formed strip of steel that provides

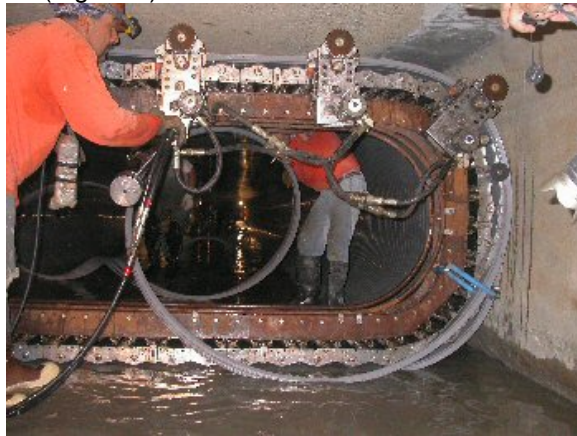
Figure 4. Winding the Liner in the Emergency Bypass Channel

Winding of the Sekisui Lining into the straight section of the EBC was concluded in 13 days. The SPR machine is capable of traveling around curves, but the EBS radius was smaller than the SPR capability. A self supporting tube of SPR material was wound above ground, and cut into segments, installed by hand, and the joints were made with fiberglass. Bracing and grouting were concluded in 12 days. Grout injection ports were located at 0-feet, 100-ft, and 200-feet into the channel. Ten cylinder samples were taken during the grouting operation and showed an average compressive strength of 6,500 psi. Twelve core samples were taken from various locations to verify that the grout had successfully penetrated the back of the profile (Figure 9). The cores were also reviewed to determine if any of the grit that had been left in the bottom of the channel had been carried into the grouted annular space by the traveling winding machine. None was observed. Coring through the perforations in the steel winding strip show complete penetration of the grout into the steel. Spark testing was conducted on the final product which passed the spark test.

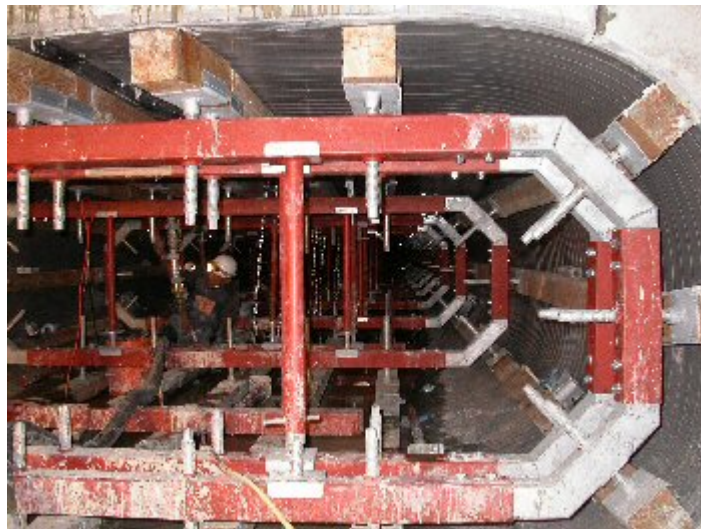
sufficient rigidity to hold the shape until temporary bracing is installed (Figure 5) and structural grout is injected behind the plastic liner (Figure 6).

Figure 5. Installed Bracing

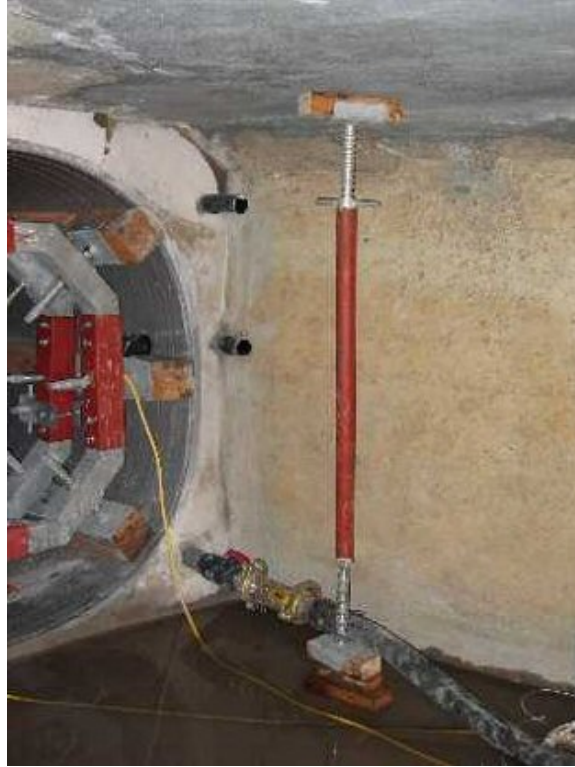
Figure 6. *Grout injection behind the braced liner*

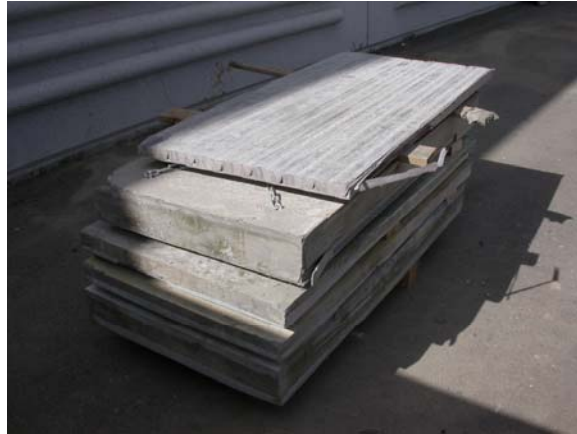
Following discussion with the project team Sekisui modified the steel strip by perforating it to create a discrete physical bond between the steel and the grout that did not rely strictly on friction. Testing to verify the steel/grout bond was conducted on beams cut from four 2'x 4' box samples prepared specifically for producing beam specimens (Figure 7).

Figure 7. Cast box samples prior to cutting beams

Beam samples were cut from the box samples and tested per ASTM C78, *Flexural Strength of Concrete (Using Simple Beam with Third-Point Loading)*. At the time of submittal these beam tests are ongoing. Qualitatively however beam specimens with thick grout seem to fail before full engagement of the steel, specimens without thick grout do not.

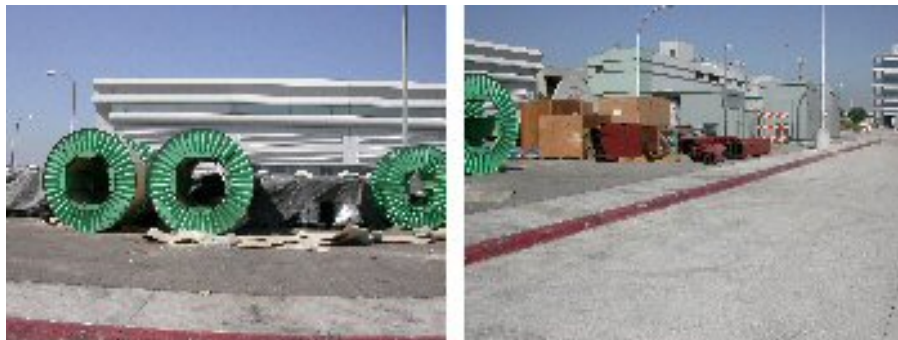
A crew of Japanese engineers and technicians was brought to the job site by Sekisui to operate the equipment and to train the Prime Contractor's staff in the installation method. Sekisui also imported all of the equipment, sand, cement and additives to be used in the installation (Figure 8).

Figure 8. Material Imported From Japan

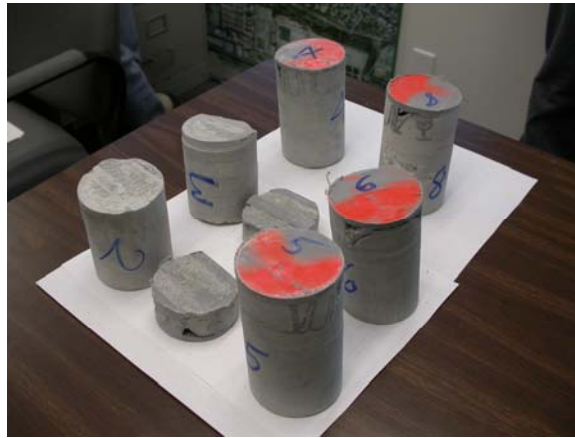
Figure 9. Grout Penetration Core Samples
